ORD Problem Solved!

Ozone Attack

Success Story

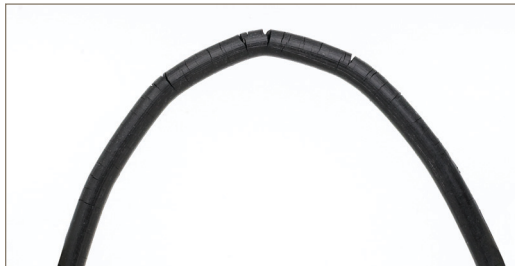
Ozone cracking is caused by an aggressive chemical attack on a double bonded seal polymer. Elastomers with double bonds in their molecular chains are highly susceptible to ozone attack. In their free state, the polymer remains unstressed, therefore the molecular interference prevents ozone from attacking the double-bonds. However, when the polymer chains are stretched, the molecular interference is disrupted, thereby exposing the double-bonds. Once this double-bond is exposed, it reacts with ozone and breaks at this point. This is then repeated for each progressively deeper layer of polymer chains within the rubber. On the surface, this shows up as cracking in the seal. This ozone cracking permits gases and fluids to pass through in an application.

A fitting manufacturer was assembling nitrile rubber (NBR) O-rings onto a standard SAE J1926/1 tube fitting. The fitting was to be used in a compressed natural gas (CNG) application. The customer was having issues with the O-rings after they had been installed on the fittings and placed into stock. The tube fittings were stocked on shelves for 2-4 weeks in a warehouse setting. When the fittings were pulled from the shelf, the O-rings had formed noticeable cracks around their circumference. These radial cracks were unacceptable for this CNG application because the gas would easily flow through the surface cracks of the O-ring forming a leak. The customer asked Parker to remedy their application problem; requesting the replacement material be low temperature capable and provide good resistance to the hydrocarbons present in CNG applications.

The cracks that were forming on the surface of the NBR O-rings, when stretched over the tube fitting, are characteristic of a failure mode referred to as ozone attack. Ozone attack occurs when a NBR O-ring is stretched and exposed to ozone for a period of time, sometimes as short as a couple weeks. The ozone that is present in the earth's atmosphere is enough to break the polymer chains that make up the NBR compound, thereby forming surface cracks on the seal.

To prevent ozone attack, Parker proposed that the customer move to a compound that would provide ozone resistance while giving equivalent or better performance in CNG. Parker's KA183-85, a hydrogenated nitrile rubber (HNBR) compound, was recommended because of its ability to meet the low temperature requirement of the application. KA183-85 also provides excellent resistance to CNG and is ozone resistant.

The customer decided to change materials over to the HNBR compound KA183-85. This material change eliminated the customer's ozone attack issues while providing them with an 85 durometer, Shore A hardness, material that was good for use in applications with a temperature range of -55°F to 320°F. The customer was very satisfied with the performance of the KA183-85 compound and reported no more instances of ozone attack.
